SALADO INDEPENDENT SCHOOL DISTRICT

FACILITY PLANNING COMMITTEE 2023

FACILITY CONDITION ASSESSMENT

FOOD SERVICE ASSESSMENT REPORT

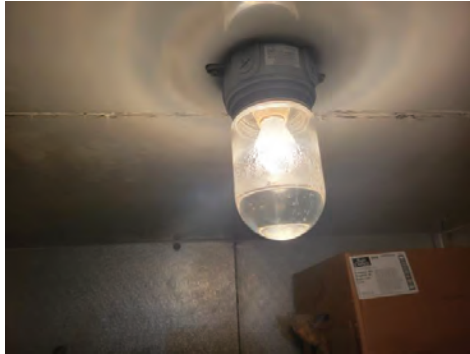
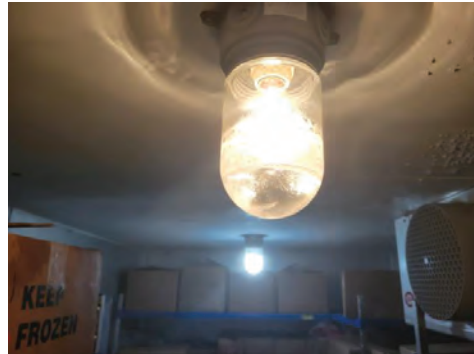
Light fixtures in both the walk-in cooler and freezer have accumulated condensation inside the lenses due to deterioration of the sealant around ceiling penetration and the interior of the electrical conduits.

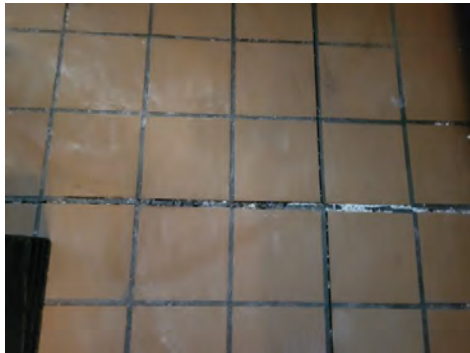
The quarry tile floor on the interior of walk-in cooler and freezer is showing signs of wear and damage.

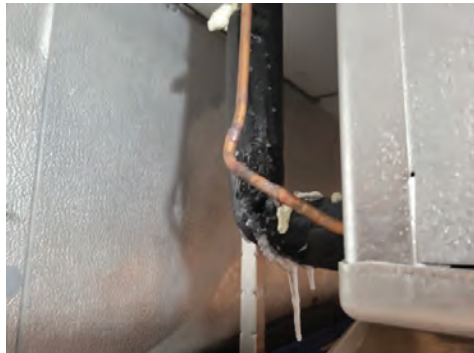
The ceiling penetration around the refrigeration lines in the freezer are not properly sealed.

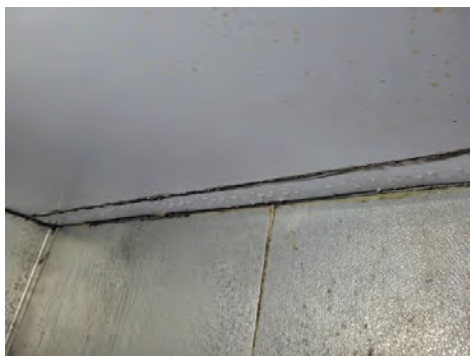
The panel seams in the interior of the cooler and freezer are leaking causing an accumulation of condensation where issue is occurring.

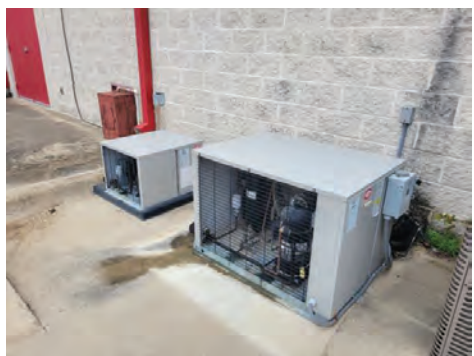
The existing condensing units for the cooler and freezer appear to be in good condition.

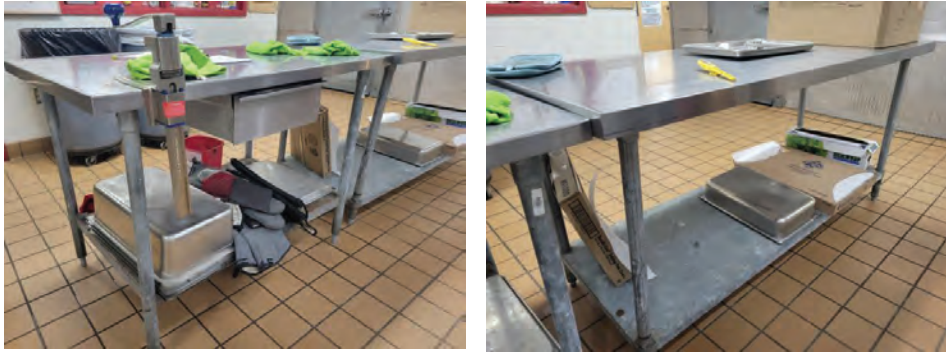
Two worktables with galvanized bases and undershelves are in need of replacement.

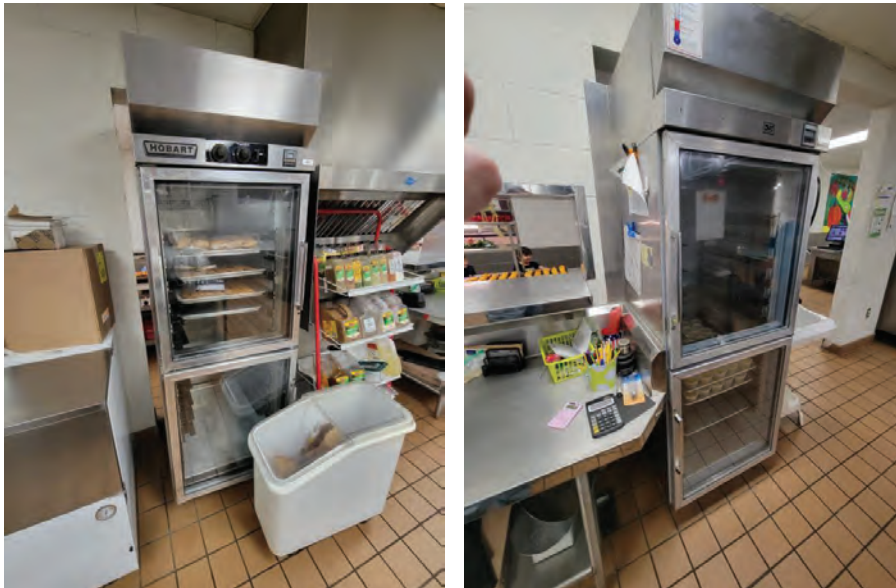
The pass thru refrigerators and heated cabinets have reached their life expectancy and are in need of replacement.

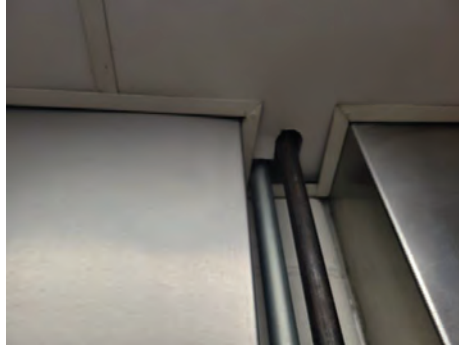
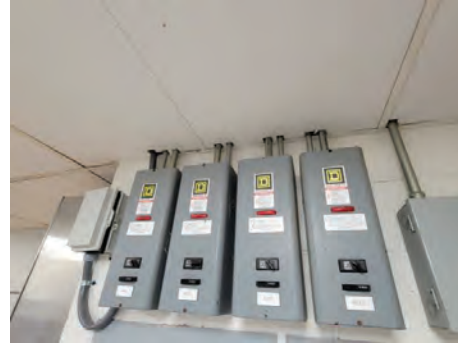
All ceiling penetrations throughout the kitchen area are to be properly sealed to prevent rodent and insect infiltration into the foodservice areas.

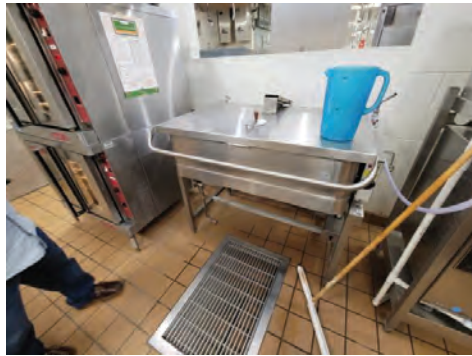
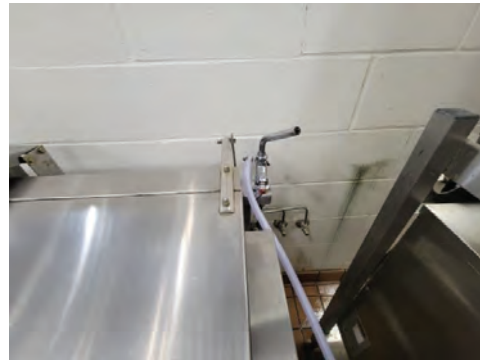
The 40-gallon braising pan has reached its life expectancy, and the fill faucet assembly is broken and not functional.

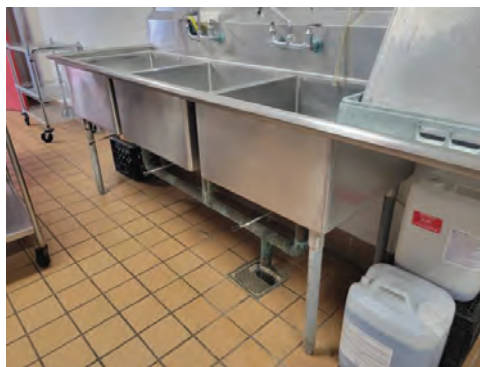
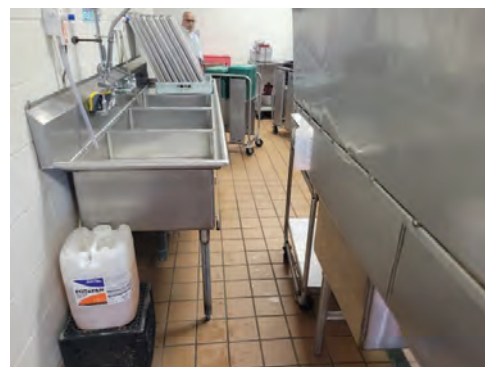
The three-compartment pot wash sink is required to have a drainboard on both ends of the sink compartments. There is not a drainboard on the left side of the existing unit.

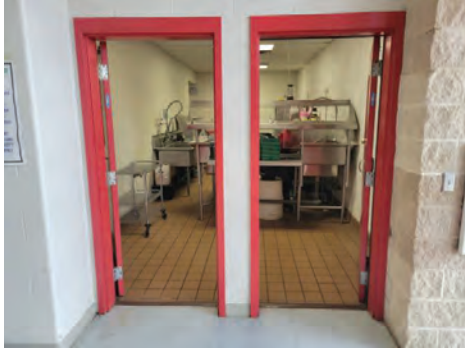
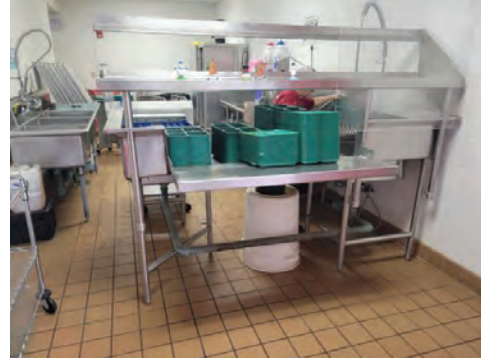
The scullery area is accessible and visual to the students that are depositing their soiled trays.

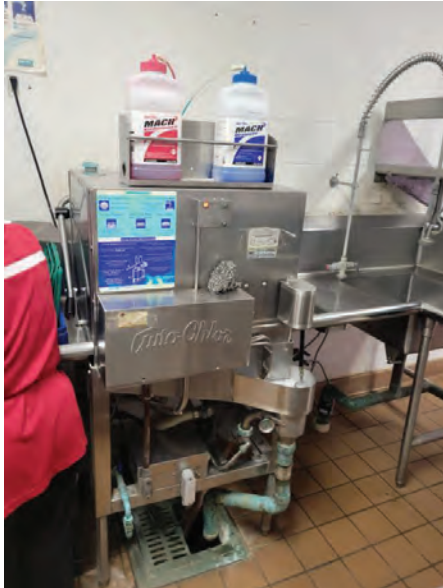
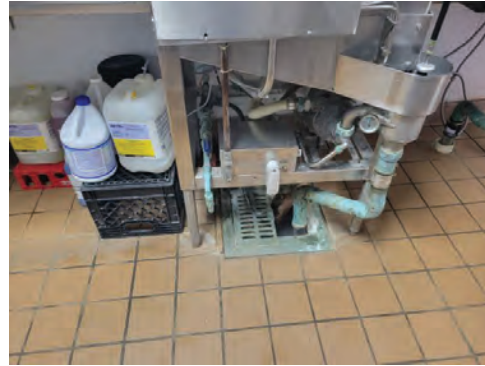
The existing single rack low temperature dishmachine is not adequate for the quantity of trays that are being washed, and there is currently not a condensate hood installed above this unit as required.

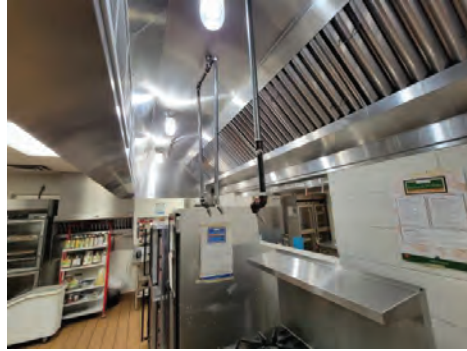
The existing exhaust hood is not equipped with the required heat sensing devices as required per the current International Energy Conservation Code.

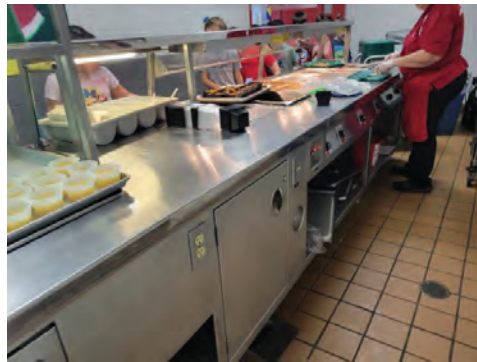
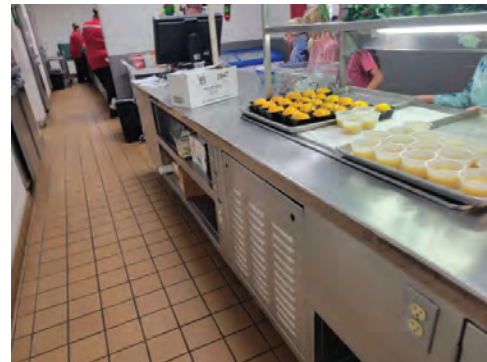
The existing serving counters are limited on temperature-controlled merchandising space, and the food shields at the hot food wells are currently a safety issue for students that can access the hot food wells.

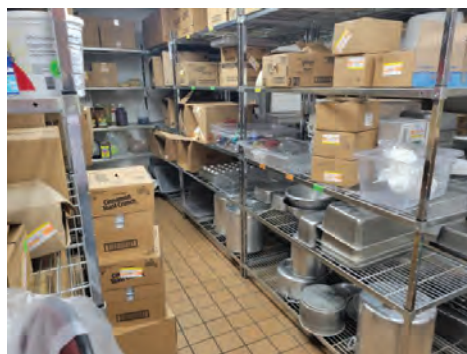
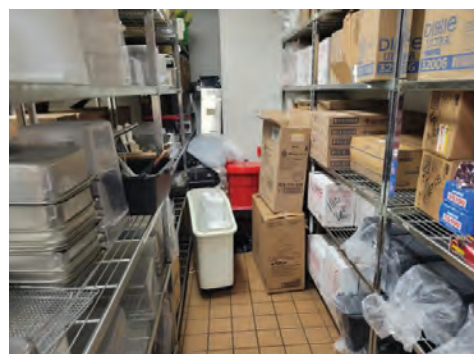
There is not adequate space in the pantry area for a 60" turning radius in the open aisles as required per the ADA accessibility standards.

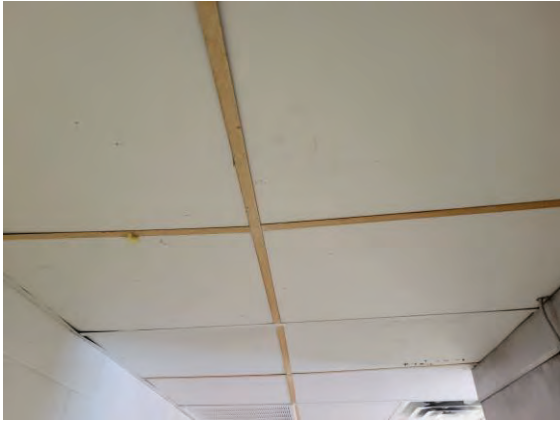
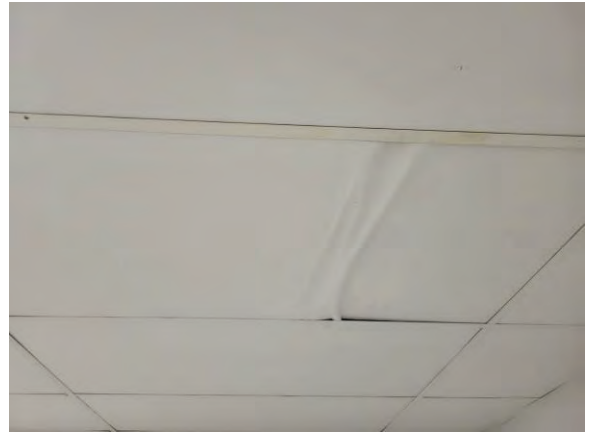
The suspended ceiling in the kitchen area is stained and damaged and some of the ceiling grids are rusted.

21. **Replace existing suspended ceiling throughout the kitchen area.**
22. **Replace the existing quarry tile floor in the kitchen area with Altro commercial kitchen vinyl flooring.**

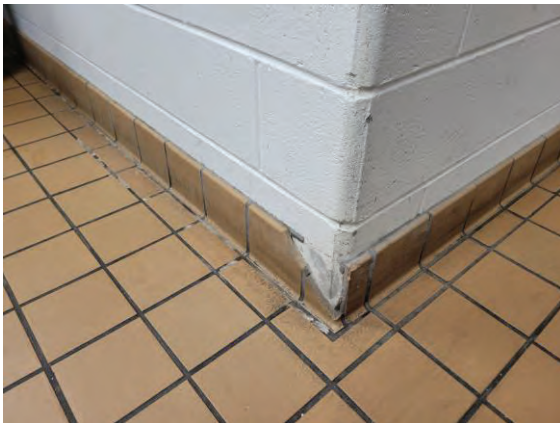
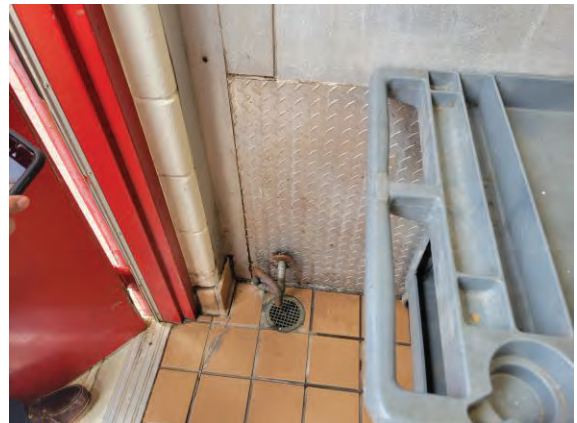
The quarry tile flooring throughout the kitchen is worn and damaged and is in need of replacement with a new finished flooring material.

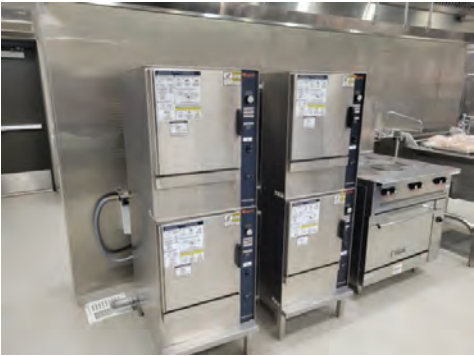
The two existing steamers are not being used. The staff recommends that these units be removed and a conveyor pizza oven be installed at this location.

3. The two (2) existing double stacked steamers are not being used. The staff requested that these units be removed and a double stacked conveyor pizza oven be installed at this location. *(Note: This may require modification to the fire suppression system in order to accommodate this equipment.) (Estimated Cost: \$49,000.00)*

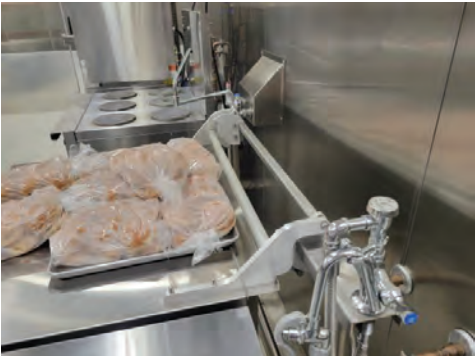
The staff requested that a pot filler with a spray head assembly be installed at the braising pan to assist with the daily cleaning of this unit.

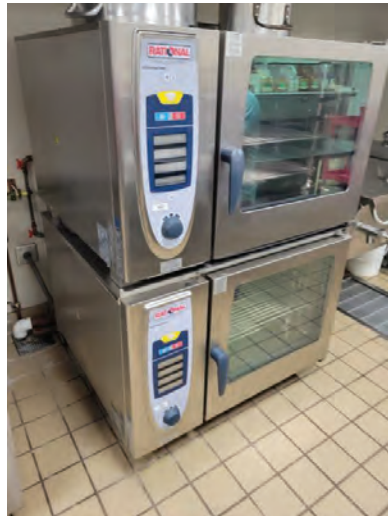
The existing combi oven is having continuous service issues and may be in need of replacement.

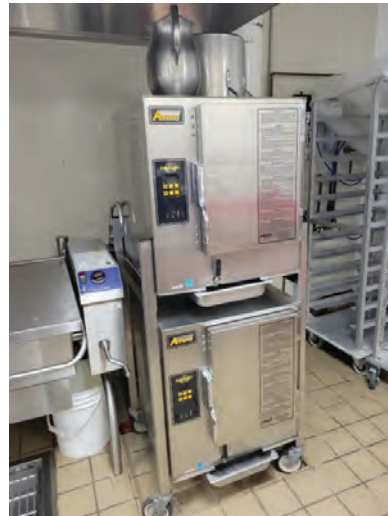
The existing steamers are not being used. The staff recommended removing and replacing these units with a two or four burner range.

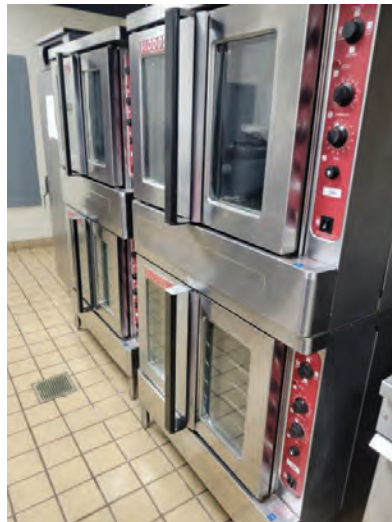
Staff recommended replacing one convection oven with a combi oven.

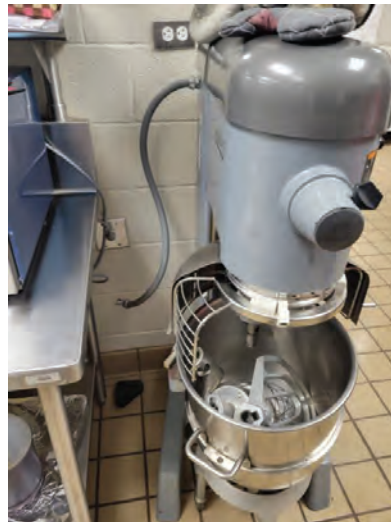
A 208V receptacle and circuit is needed for the 30-quart mixer.

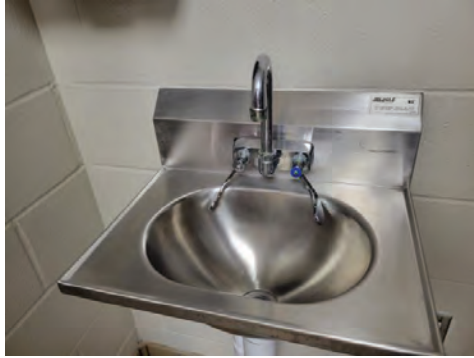
The faucet on the hand sink next to the cooking line is not functional.

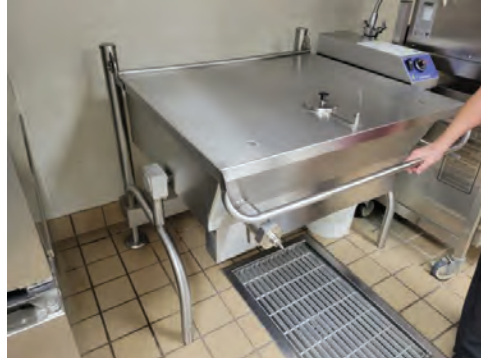
The handle for the tangent draw on the braising pan is missing.

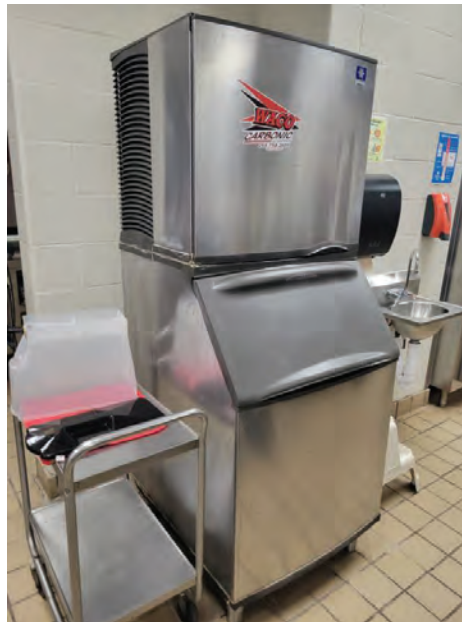
The ice machine was not working and service is needed. Unit appears to be in good condition otherwise.

- 14. Consult with a service agency for repair of the ice machine. (By Owner)
- 15. Replace the existing quarry tile floor in the kitchen area with Altro commercial kitchen vinyl flooring.

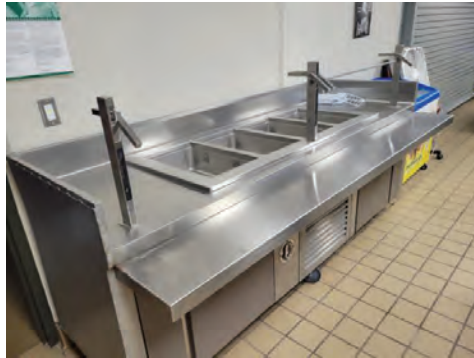
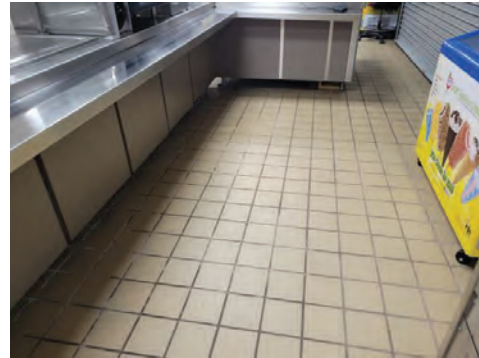
Existing salad bar counter is not being used and can be removed to allow for additional space in the serving area.

The existing quarry tile flooring in the kitchen and serving areas appears worn.
